## VEHICLE INSPECTION REPORT

**SJ71HSO**

### Fiat Doblo Work Up 1.6 MULTIJET 16V II

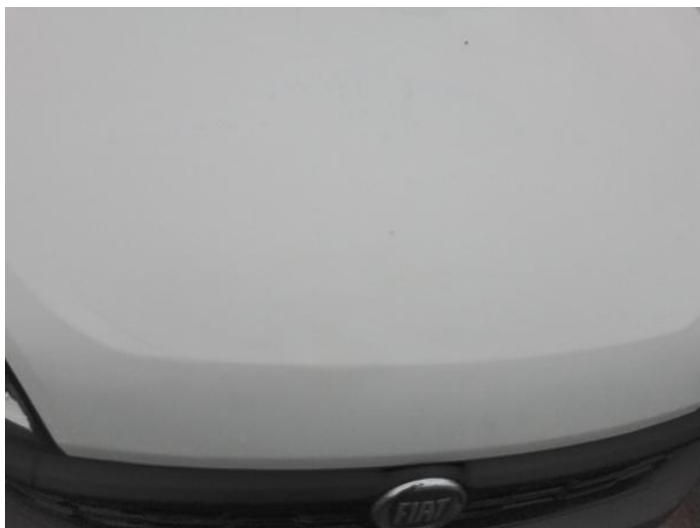
1: Bonnet  
Chipped  
Multiple Chips

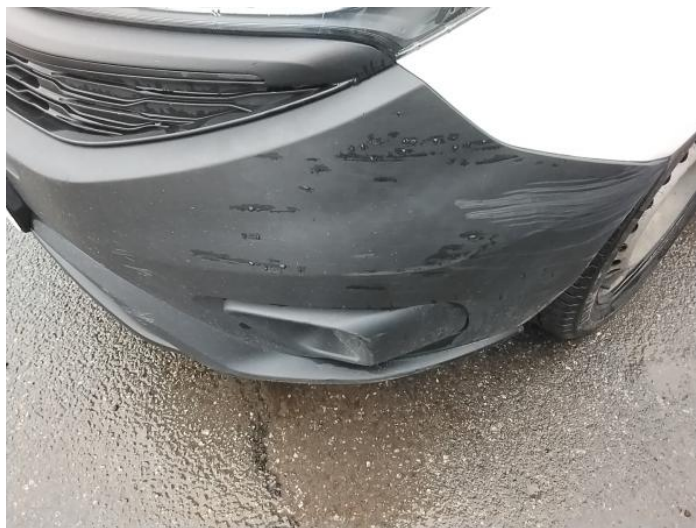
2: Bumper Front  
Scratched  
Over 100mm Thru Paint

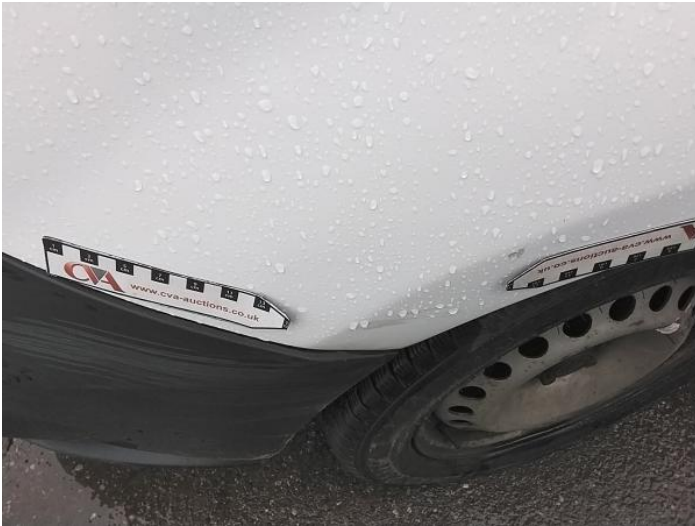
3: Wing nsf  
Dented  
With Paint Damage

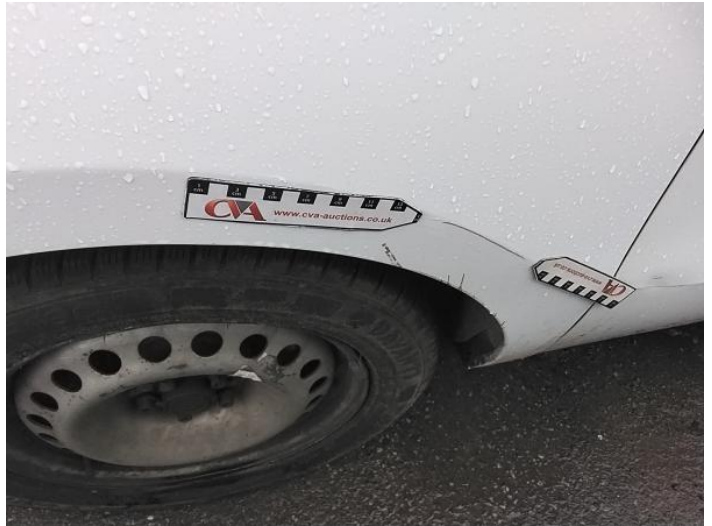
4: Wing nsf  
Scratched  
Over 25mm Thru Paint

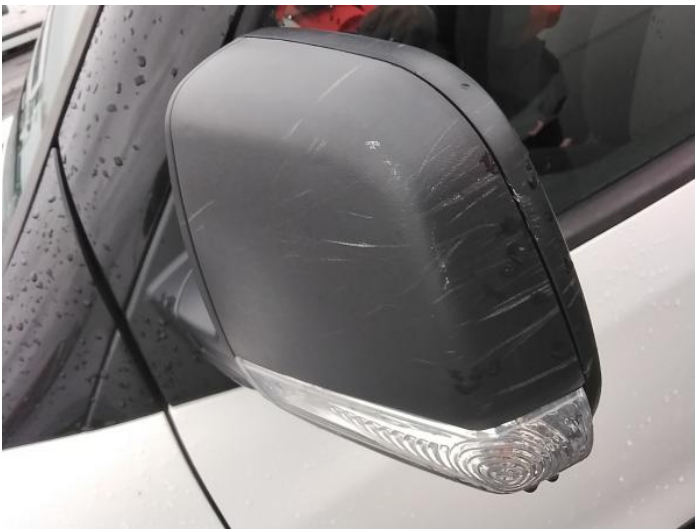
5: Door Mirror Assy nsf  
Scuffed (Unpainted)  
Over 100mm

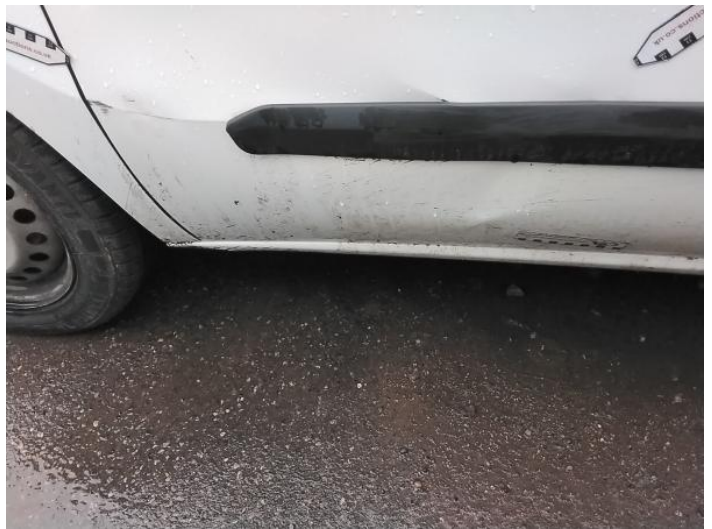
6: Door nsf  
Dented  
Over 30mm

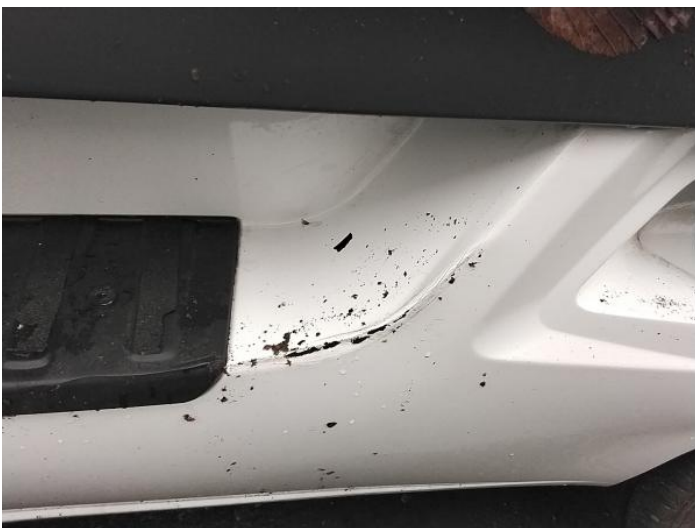
7: Qtr Panel nsr  
Scratched  
Over 25mm Thru Paint

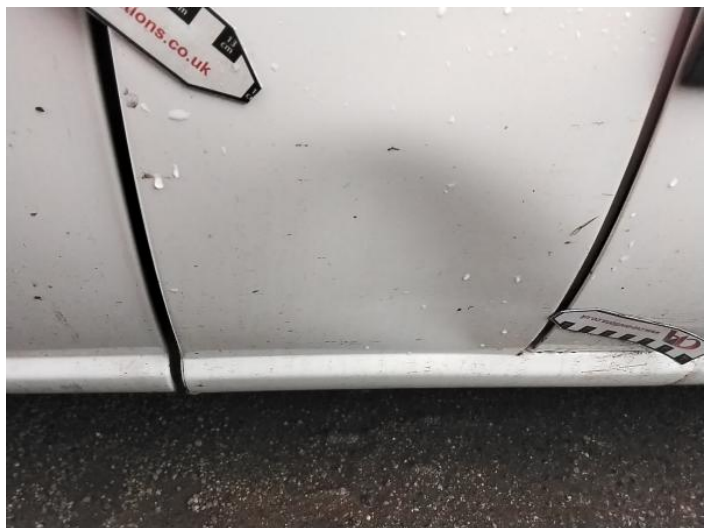
8: B Post os  
Dented  
Over 30mm

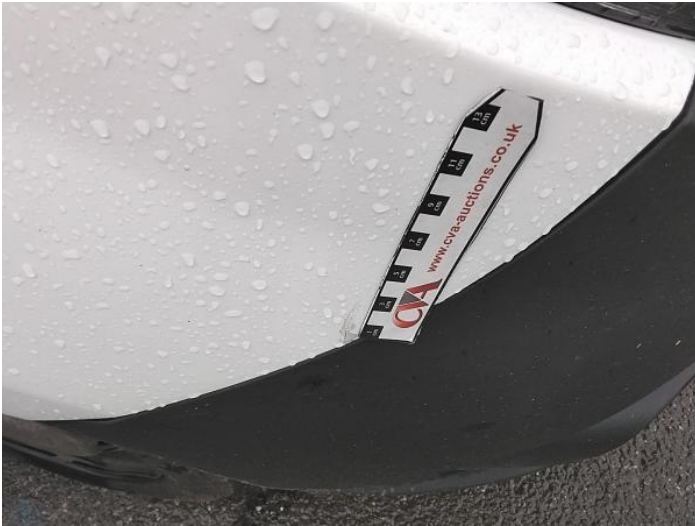
9: Wing osf  
Scratched  
Over 25mm Thru Paint

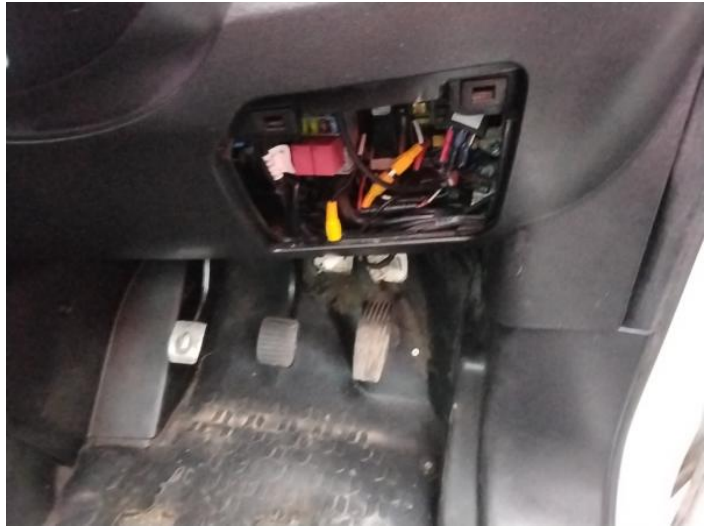
10: Fascia Panel  
Missing  
Replace

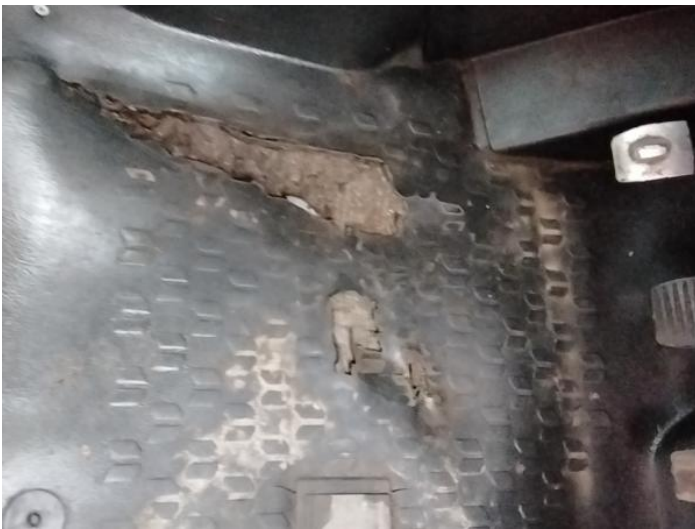
11: Carpets Front  
Holed  
Over 3mm

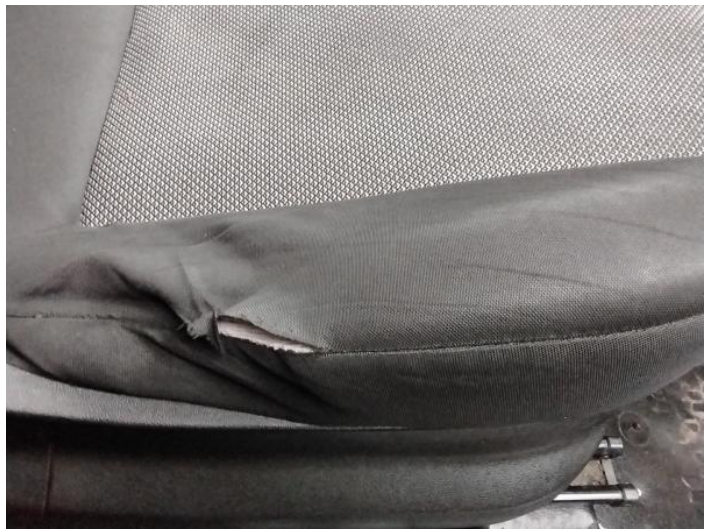
12: Seat Base Cover osf  
Torn  
Over 3mm

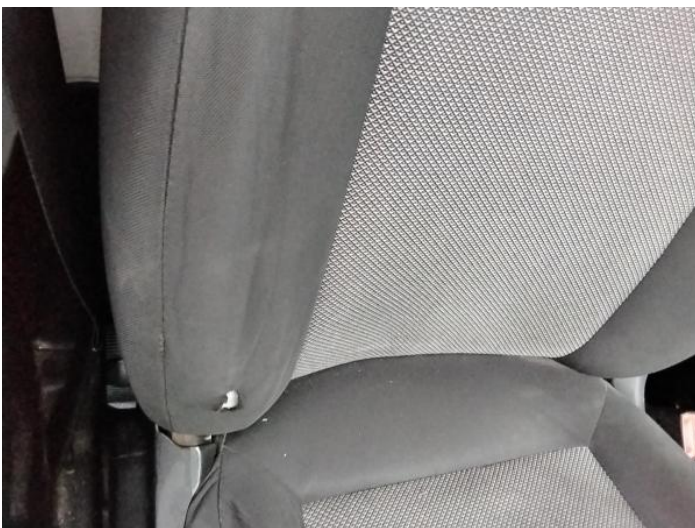
13: Seat Back Cover osf  
Holed  
Over 3mm

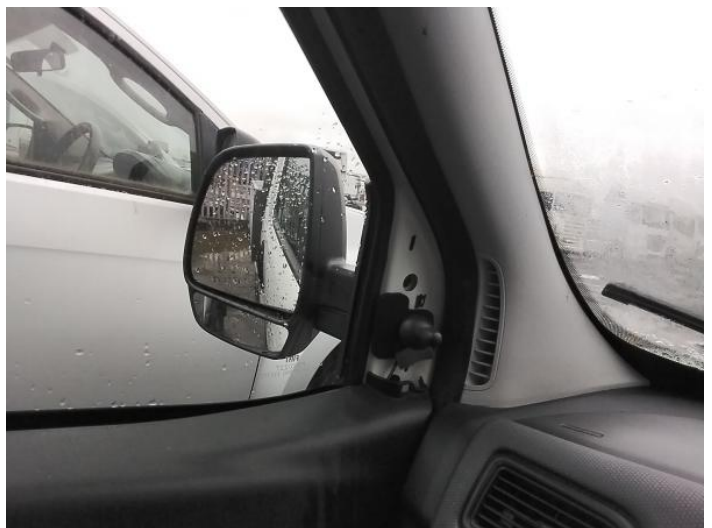
14: Fascia Panel  
Missing  
Replace
